Critique of Incident

**"Improper Modification of High Voltage Connections to
Kepco Power Supply"**

July 15, 2004

"Improper Modification of High Voltage Connections to Kepco Power Supply"

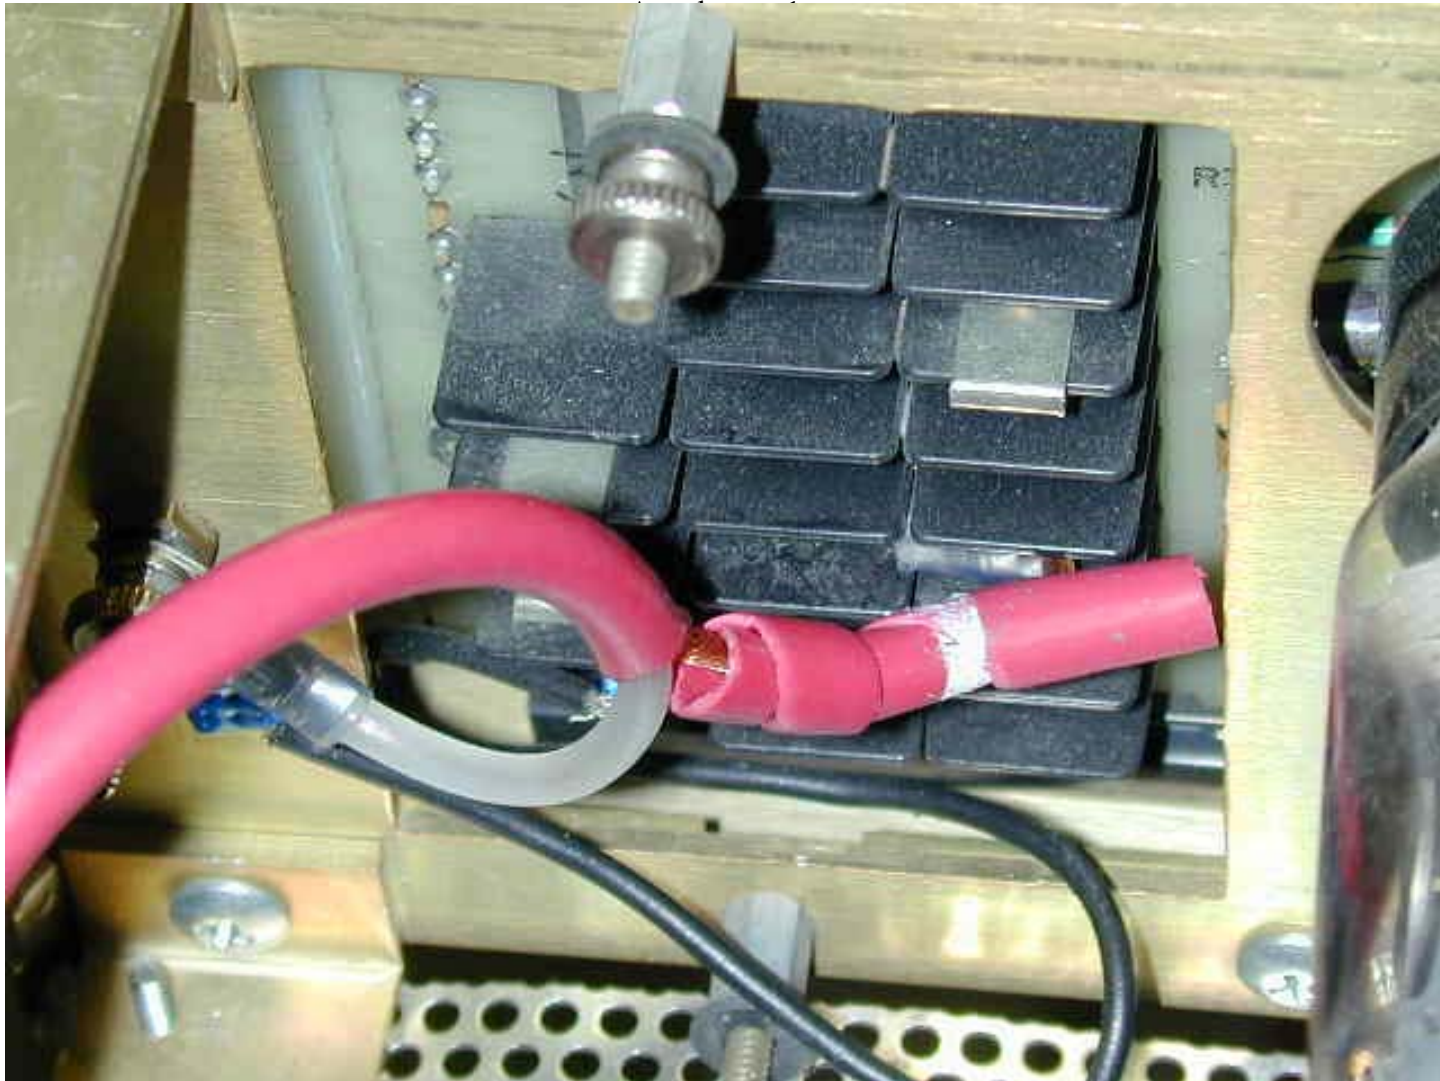
In seeking to reverse the polarity of the voltage applied to the sample, the students connected the center conductor of the high voltage cable to the grounded negative output of the power supply and connected the copper shield of the cable to the positive output. In this configuration, the outer shield of the cable and the shell of the SHV connector had a positive potential, and when the cable was connected to the vacuum tank feed-through, the power supply output was directly shorted to ground. If the connectors had been disconnected from the vacuum tank and held by someone (who was grounded) when the power supply was turned on, an electrical shock would have occurred.

The error occurred because the students did not understand the contacts at the rear of the power supply and the nature of the connections that they made. The polarity could have been successfully reversed if the center conductor had been connected to the negative output of the power supply and a connection was established to the positive output, chassis ground and the cable shielding. They apparently believed they were grounding the positive output when they connected the copper shield to the positive output. However, any changes to the configuration without the benefit of power supply documentation and guidance from personnel familiar with the power supply was a risky undertaking and contrary to the training received by the users and the responsibilities assigned to all users.
